Quality Assurance and Source Inspection

Contract #: 04-0120F4Cty: SF/ALA Rte: 80 PM: 13.2/13.9File #: 69.28**WELDING INSPECTION REPORT****Resident Engineer:** Pursell, Gary**Address:** 333 Burma Road**City:** Oakland, CA 94607**Report No:** WIR-001181**Date Inspected:** 09-Jan-2008**Project Name:** SAS Superstructure**OSM Arrival Time:** 630**Prime Contractor:** American Bridge/Fluor Enterprises, a JV**OSM Departure Time:** 1530**Contractor:** Zhenhua Port Machinery Company, Ltd (ZPMC), Changxing Island **Location:** Shanghai, China

Bridge No: 34-0006**Component:** 77m, 89m, 114m and #1 deck mock-ups**Summary of Items Observed:**

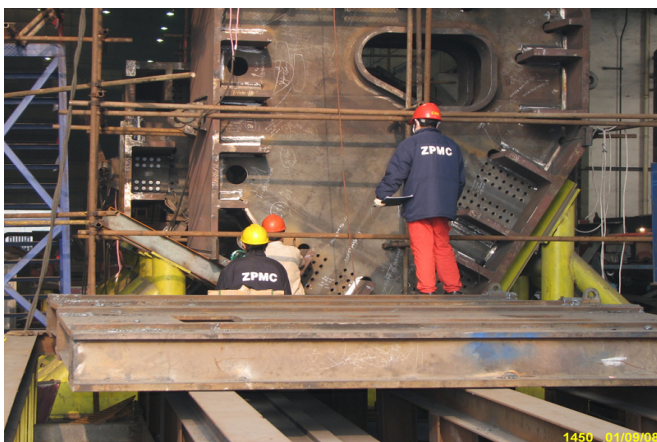
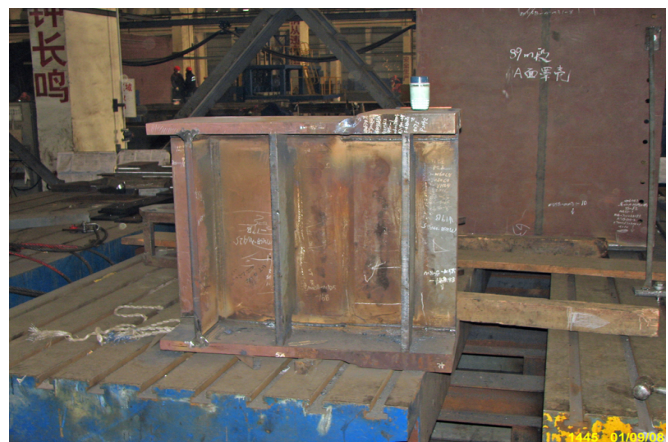
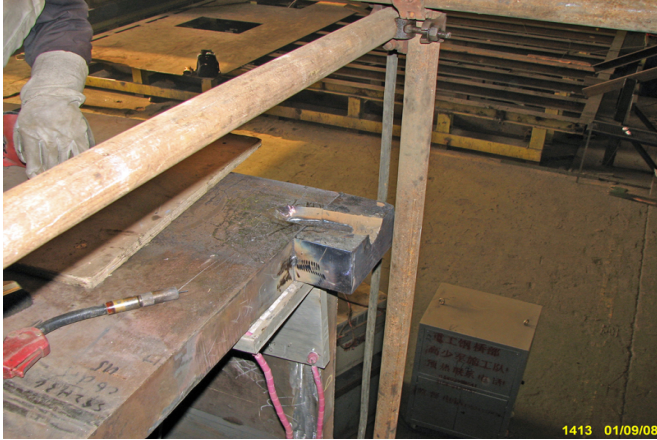
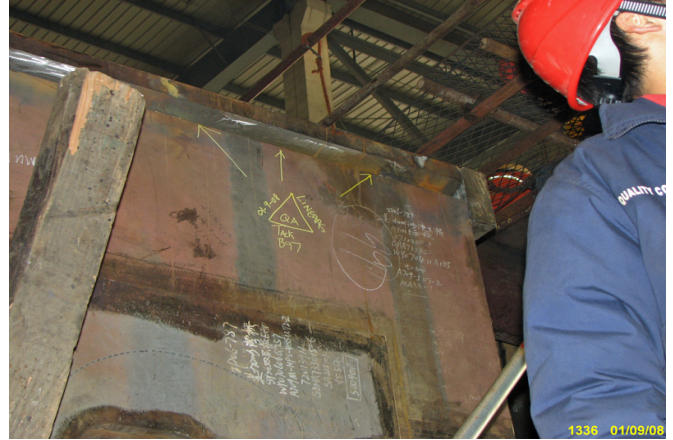
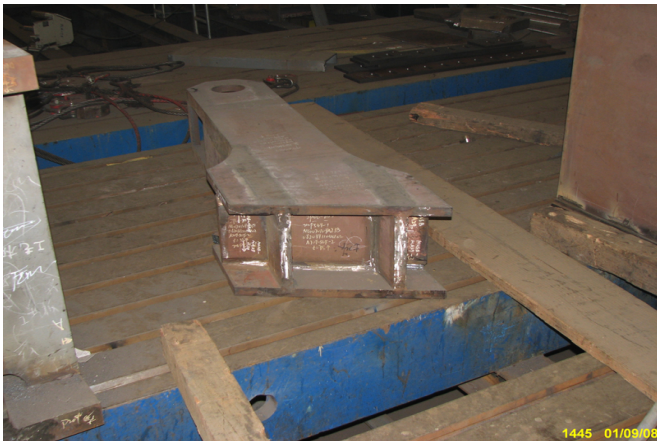
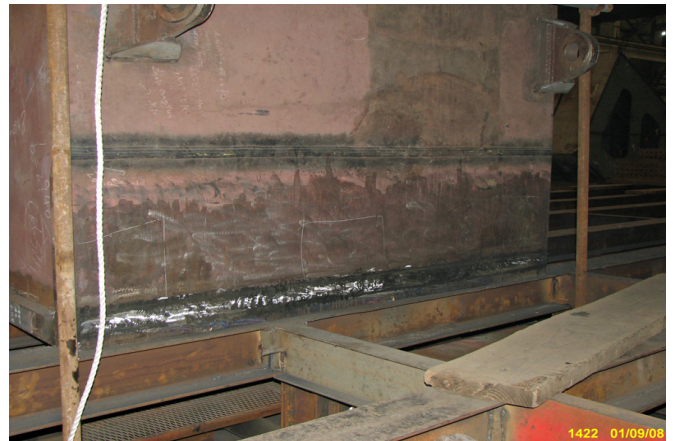
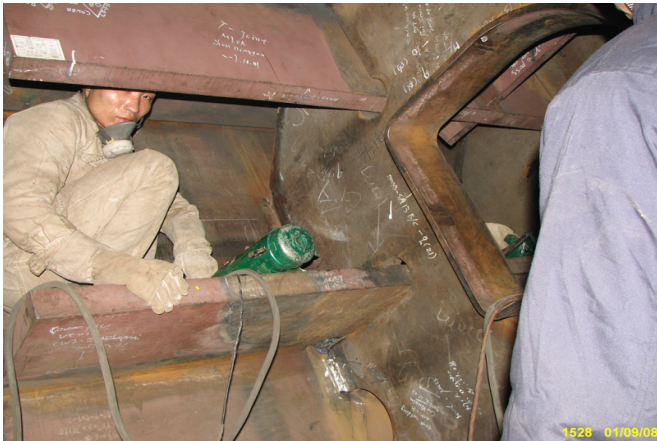
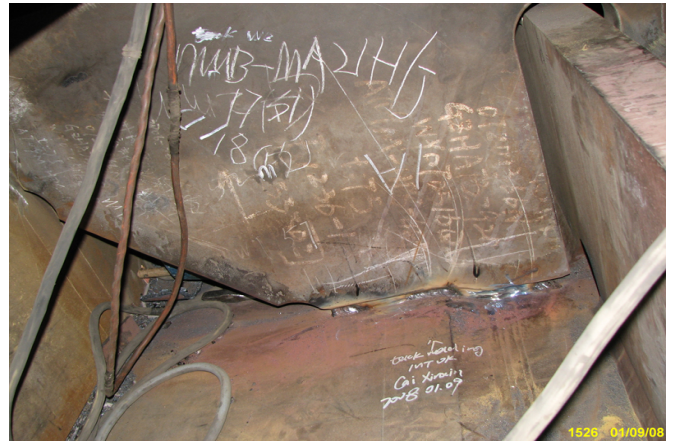
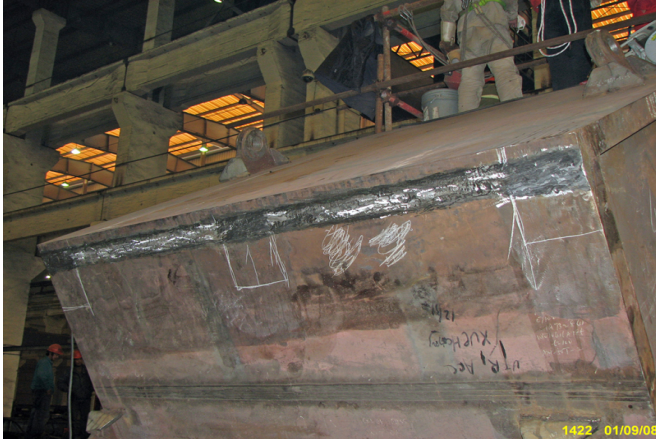
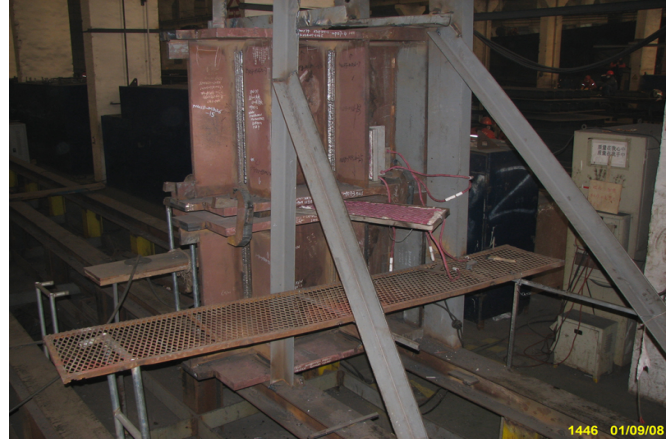
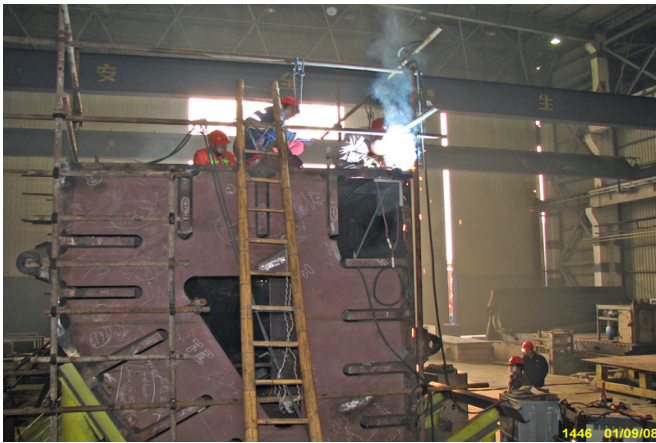
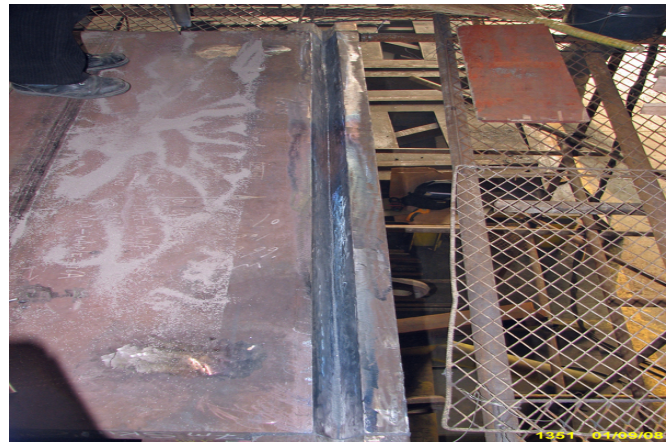
89m mock-up had welding operation ongoing. Upon visual inspection of external Plate E to Plate A weld joints, three tack welds had longitudinal cracks noted for their entire lengths. The defective in process welds were shown to ZPMC CWI Zhao Chen Sun.

Diaphragm to skin plate attachments weld numbers MUB-MA21 H/J-13, -14 and MUB-MA21 H/J-17, -18 were being made upon the Caltrans representatives arrival. Both sides of the joint were being welded at the same time, immediately causing the Caltrans representative to produce 200 degree centigrade and 232 degree centigrade Tempilstik brand temperature indicators. Both temperature indicators readily melted. The Caltrans representative asked for the ZPMC CWI, Ye Yong Jun, to take laser pyrometer temperature readings. The indicator provided temperature readings from 250 to 262 degrees centigrade. The ZPMC CWI stopped the four welders, (-17) Guo Dengyum (037997), (-18) Shen Yong (066257), (-13) Fu Yanjie (066268), (-14) Li Zhengxu (066179), immediately. The Caltrans representative asked the CWI if he was aware of the WPS parameters. He stated that he was. No logical explanation could be provided for the discrepancy.

Included below are digital pictures that support the observations recorded within this report.
